**KORDON TERMITE BARRIER**

door / sill - detail 3

kd 048f

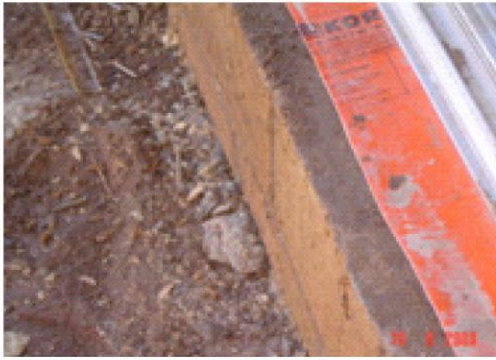
Photo 1

shows Kordon cut back from brick face to allow secure fixing

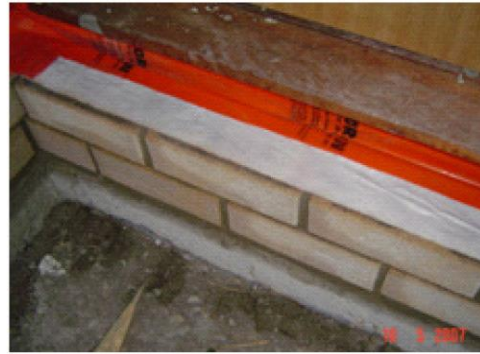
Photo 2 (option)

shows Kordon orange plastic cut back brick face to allow secure fixing

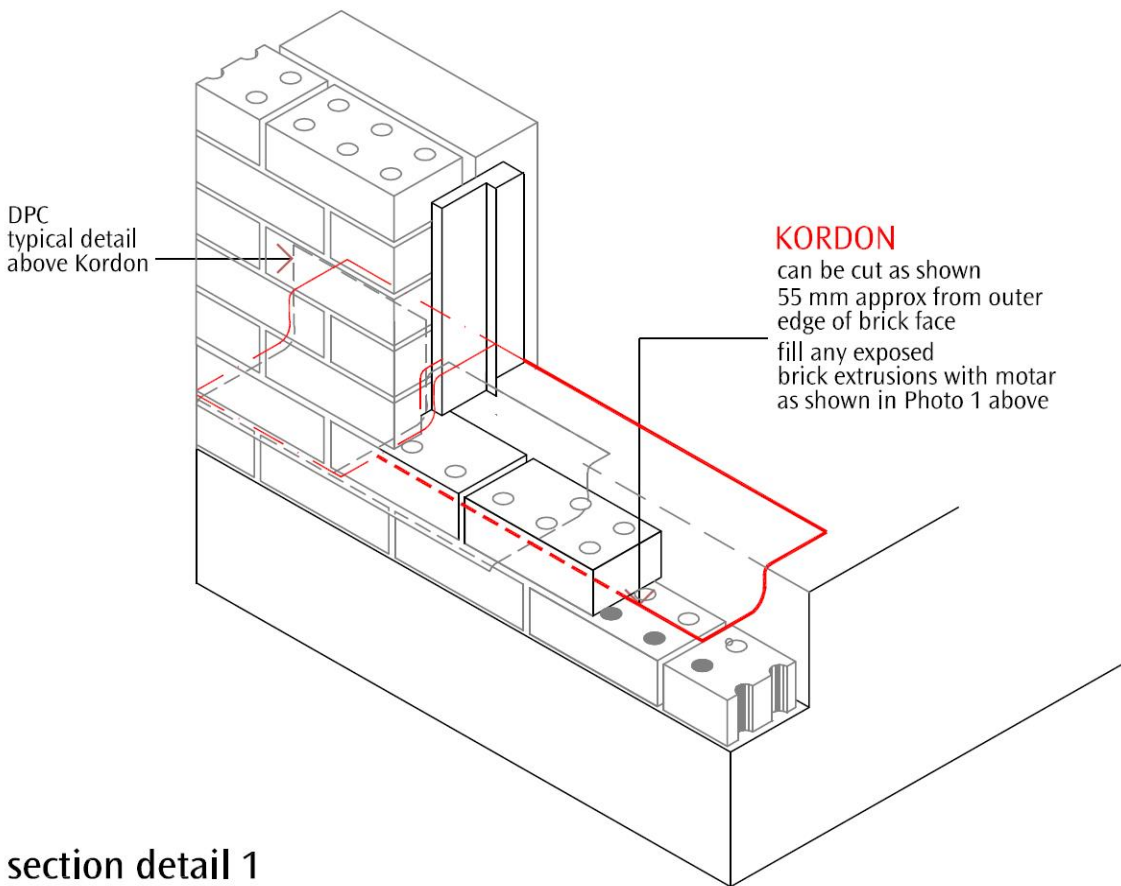
section detail 1

typical wall opening at 2 brick rebate construction
